Manhole Inspection Summary

Manhole # S31UU_024MH

Location Address: **415 FOX ST**

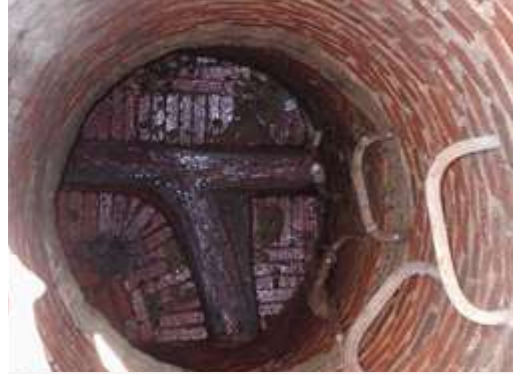
Comments **Based on the O12 pipe picture and the map the Top View and the pipe configuration is correct.**

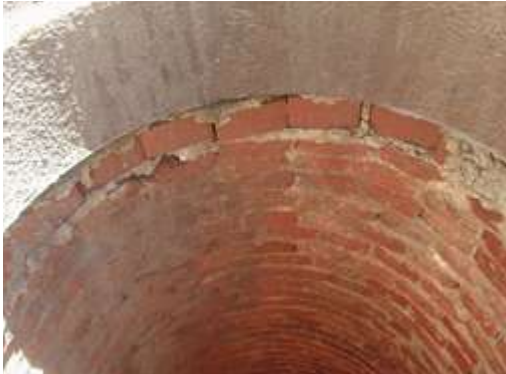
Defect

Barrel infiltration. Corroded steps.
Evidence of surcharge - Bench debris.

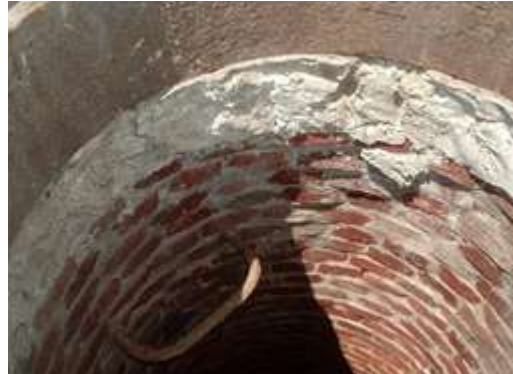
Defect

Frame leaks. Adjustment and Corbel
deterioration and infiltration - other side.

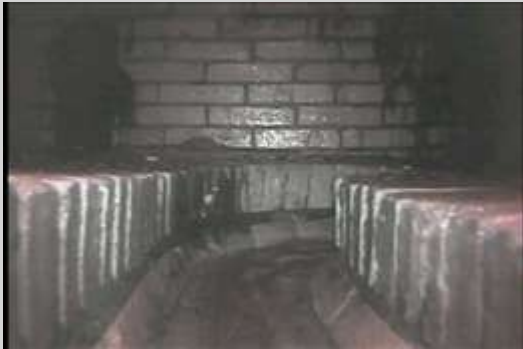
8 in. Circular Gravity Sewer Pipe Out @ 12 O'Clock

Barrel infiltration.

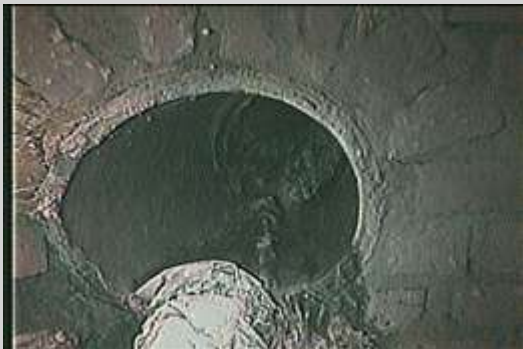
8 in. Circular Gravity Sewer Pipe In @ 3 O'Clock

Deposits: ☐ None ☐ Mud ☐ Sludge ☒ Debris ☒ Grease

Silt Depth: **3** (in.) Deposits Extent: **Medium**

Infiltration: **Evidence** Pipe Seal Cond: **Cracked**

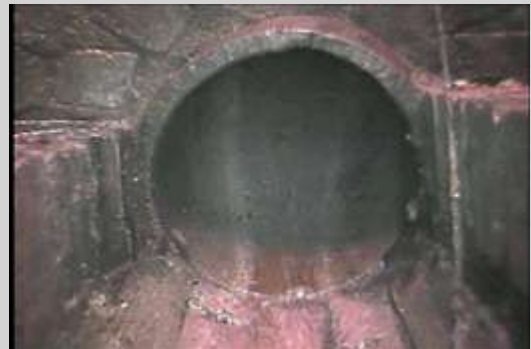
Drop In @ 3 O'Clock

Drop: **Outside** Rod and Bar
Angled: **Yes** Reading: **10.44** (ft.)
Inv Depth: **11.44** (ft.)

Drop Condition: **Partly Clogged**

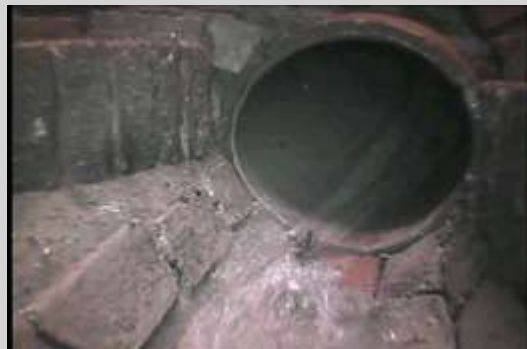
Pipe In @ 6 O'Clock

Channel deterioration.

Pipe Seal Cond: **Cracked**
